Sir Richard Burton Mausoleum

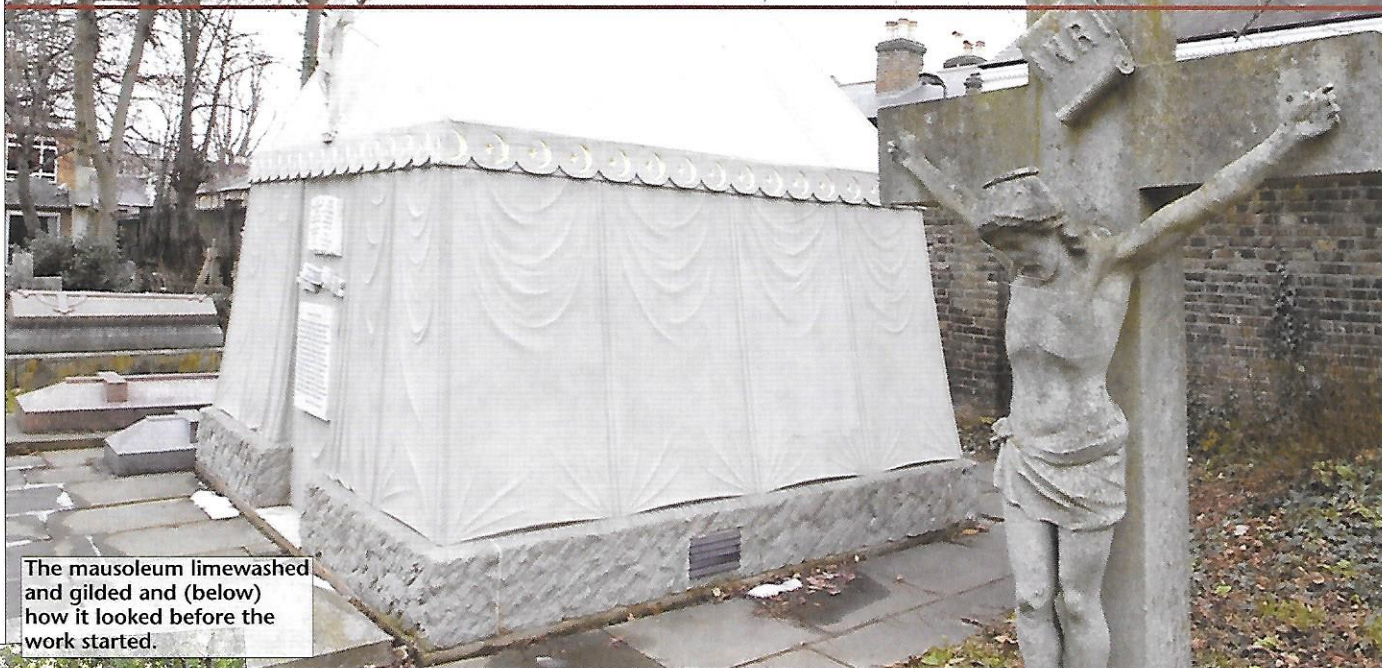
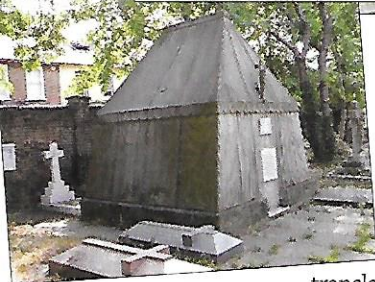
The mausoleum limewashed and gilded and (below) how it looked before the work started.

As well as general soiling dating back to the time it was built, when the nearby houses and trains would have been burning coal that left carbon deposits, the structure was covered with bird droppings, algal growth and lichen (the lichen was particularly at the back where the structure is shadowed from the sun).

On the exterior, a Tensid Aquila steam pressure cleaner made short work of algae and lifted the bird mess and general soiling, while three applications of Microtech 25X biocide removed the patches of lichen and should stop it coming back, at least for a while. There was some spalling that was repaired using lime mortars to smooth the edges but not to fill the indents completely, leaving the weathering to show as an integral part of the structure's history.

To finish off, the mausoleum was given a lime wash maintenance coat that English Heritage insisted on to help keep moisture out. To avoid being too bright it was coloured with synthetic French Ultramarine. And it should stay cleaner now because the trees around the memorial have been cut back. It is anticipated that the lime shelter coat will need renewing about every four years.
